Final Report
Incidental Harassment Authorization
June 28, 2015 – June 27, 2016
Issued to the City of San Diego for
La Jolla California Children's Pool Life Guard Station
Construction and Harbor Seal Monitoring

Executive Summary

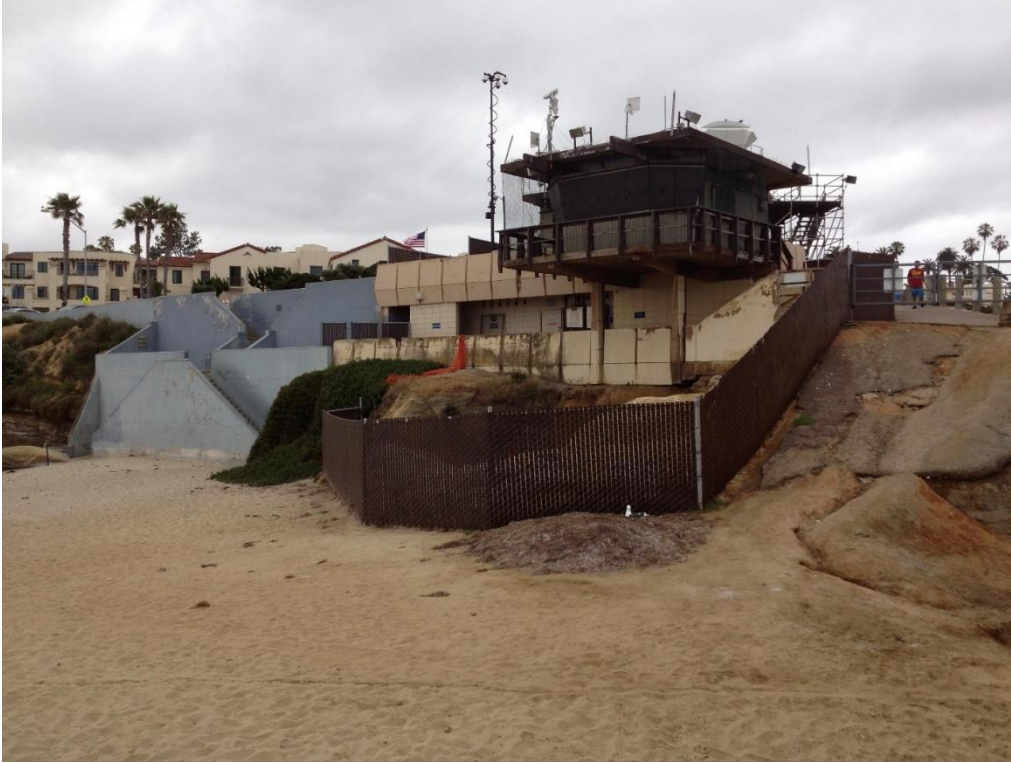
Figure 1. Original Lifeguard Station from beach level at Children's Pool, La Jolla, CA.

-Please see d) above regarding the monitoring plan, photos, and videos, which was followed. During the first year H&A accessed the WAN camera via computer to document seal hauling behavior (especially at night) to obtain peak daily counts until the camera was removed (approximately August 1, 2013; it was mounted on the roof of the old lifeguard station which was demolished Figure 1 above). The camera has not been redeployed.

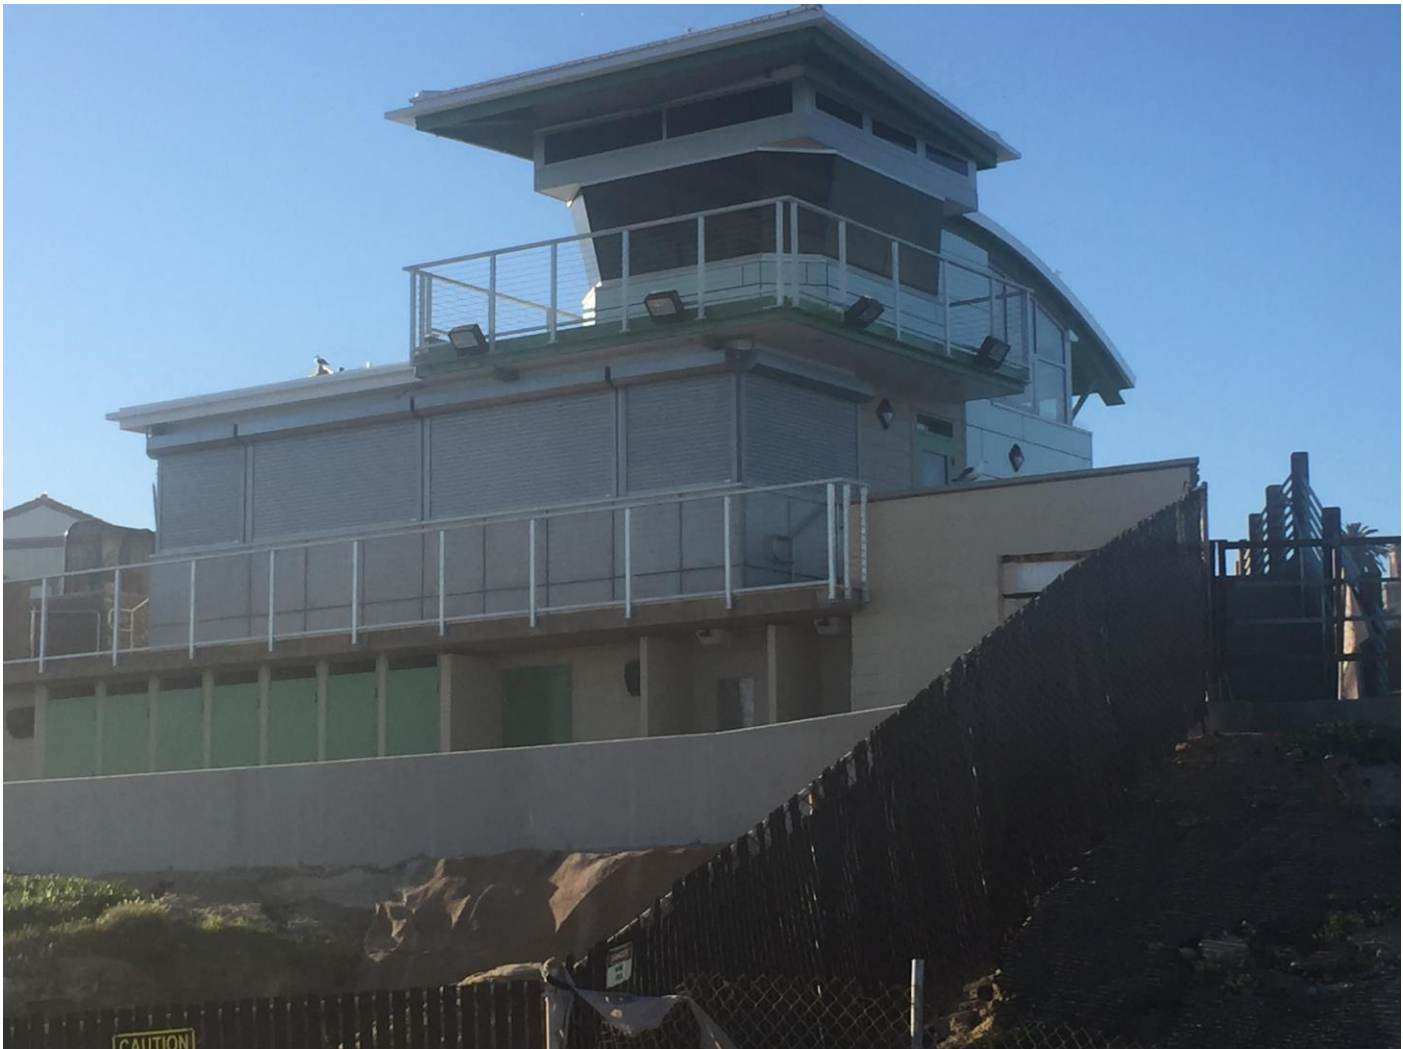
The new station is a three-story, partially sub terrain - 1,877 square-foot building with beach-access-level public restrooms and showers, lifeguard lockers, and sewage pump room; a second level containing two work stations, observation room, kitchenette, restroom, and first aid station; and a third 'observation' level including a single occupancy observation space, radio closet, and exterior catwalk (Figure 2).

Figure 2. New CP Life Guard Station.

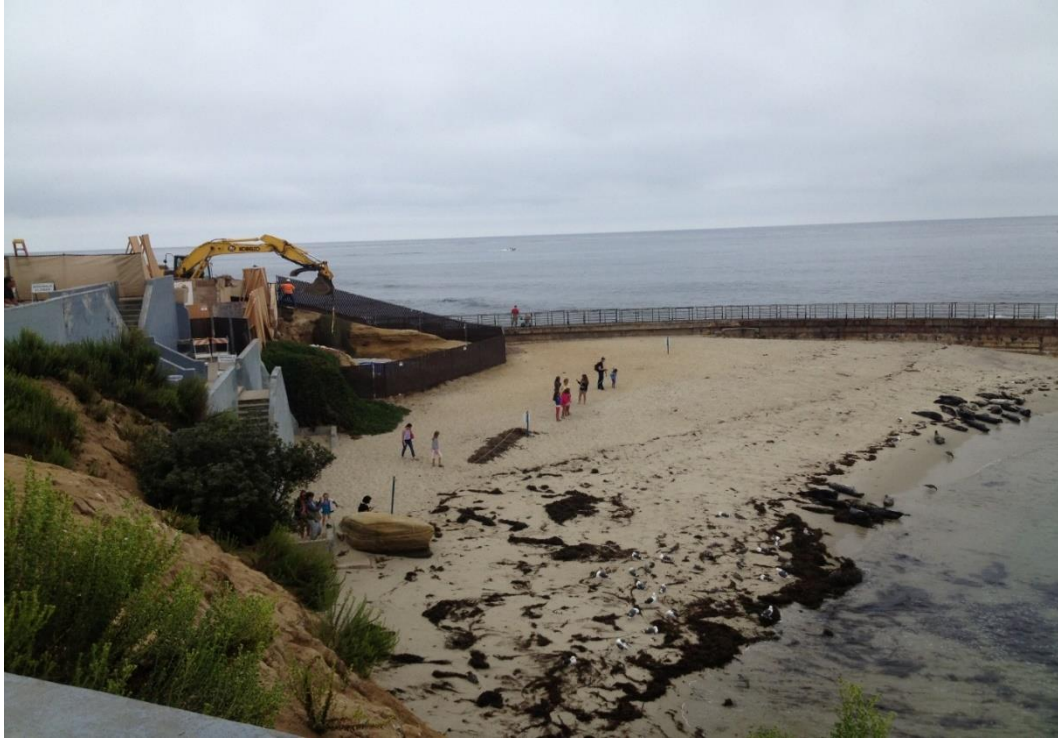
Figure 3. Excavator removing debris from beach level and over visual/acoustic barrier during first year.

Note seals and people on CP beach.

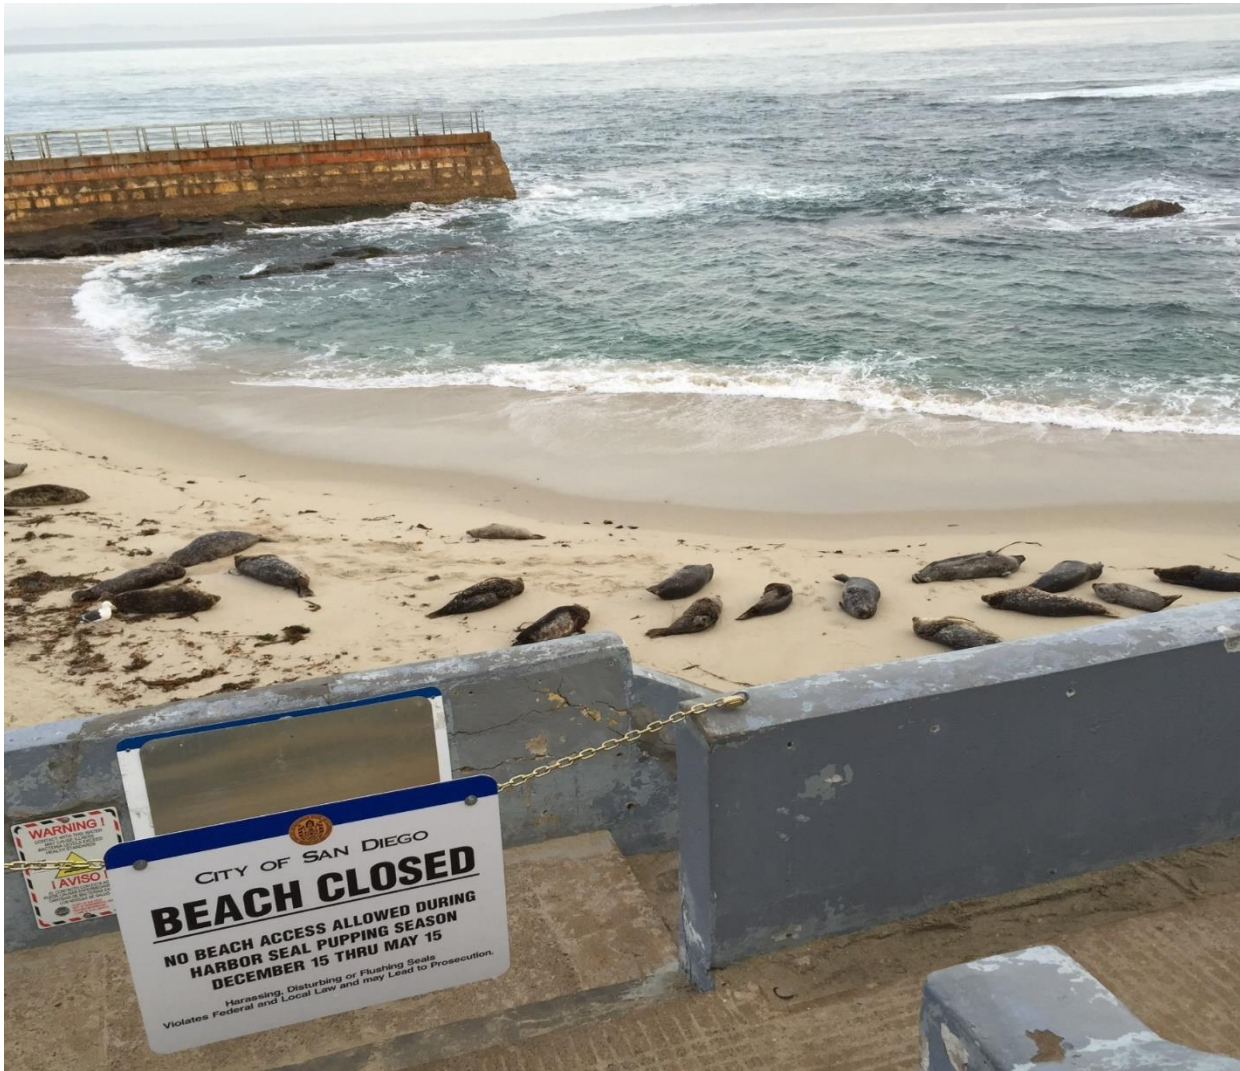
Figure 4.
Children's Pool
Beach closure
sign installed by
the City of San
Diego on
December 15,
2014 and 2015.

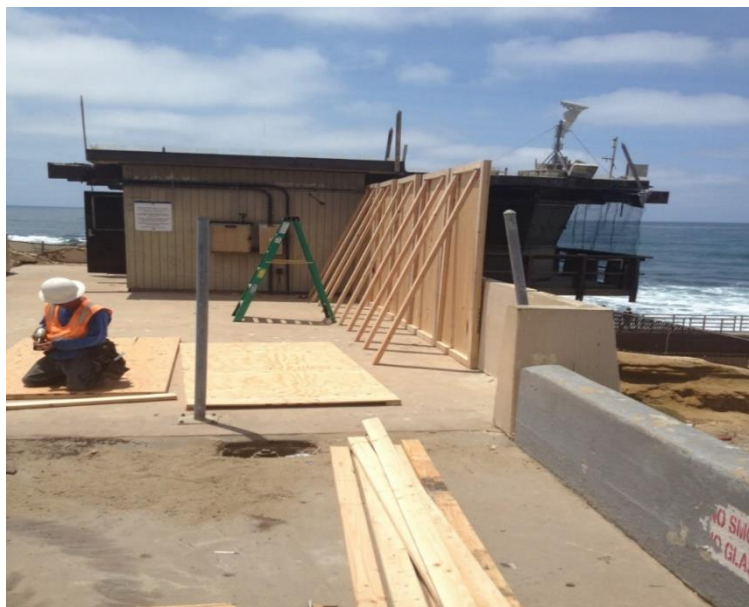
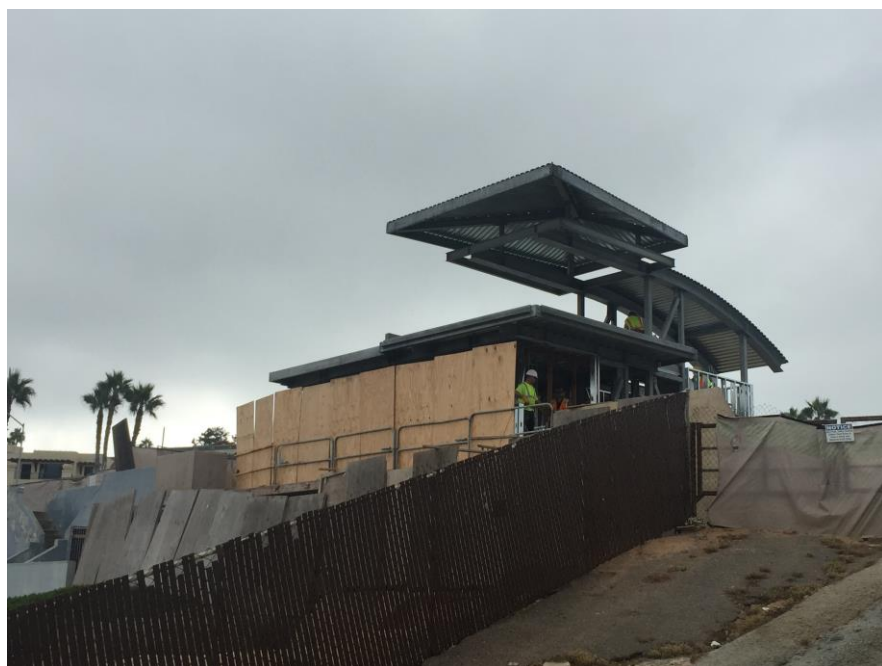
-Sheets of 4 ft. by 8 ft. by 5/8th inch plywood framed with wooden two by fours were used to create the visual/sound barrier. The sheets of plywood were stood upright (8 feet tall) and held up with two wooden two by fours hinged to the top of the frame, so they could be collapsed and be moved depending on equipment location and need for access by equipment (See figures 6, 12, 14, and 15). When used, these were quite effective. We came to this conclusion subjectively as the seals did not appear to alert to the same sounds that did alert them without barriers. We assumed this occurred because there was no visual cue with which to associate the sound. Also, the barriers likely dampened sound levels but we did not comparatively record sound levels. Barriers were not used from December 15, 2015 through April 29, 2016 during construction carried on in the 2015-16 pupping period.

Figures 6. Above: building visual/acoustic barrier as

seen from monitoring location: Top of Stairs (at juncture of tan and gray walls) next to construction site and old station; below: barriers in place during construction

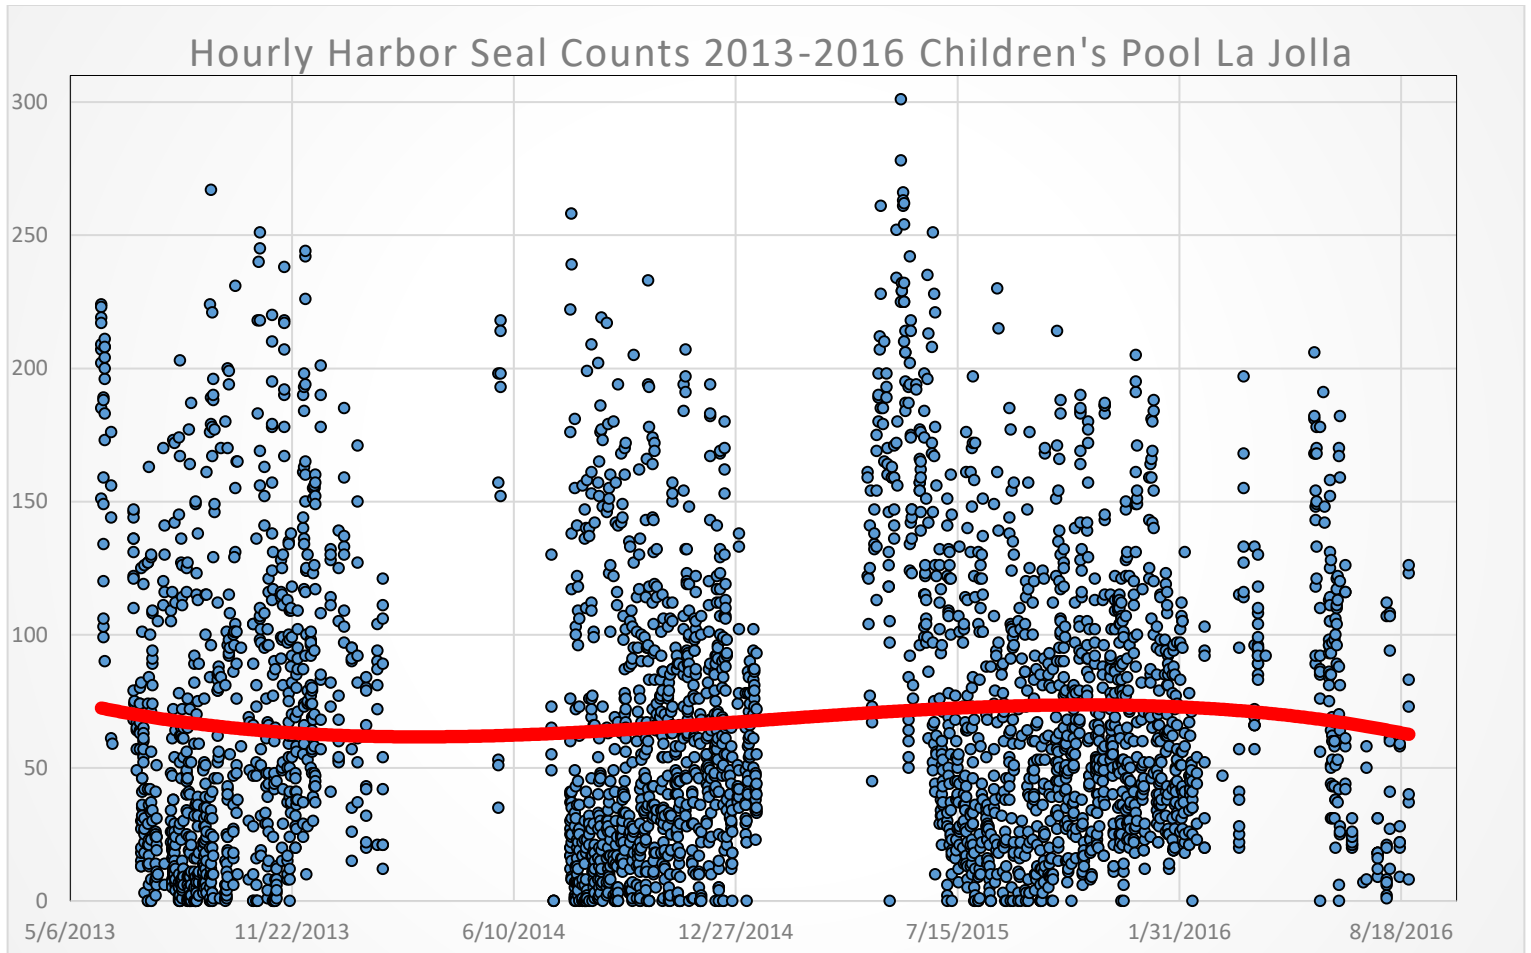
Figure 7. Harbor seal counts during 2013, 2014-15, and 2015-16 at Children’s Pool, La Jolla, CA. Counts total Children’s Pool Beach, South Casa Beach, Seal Rock, and the reef area outside the CP break wall. Trend line (Red) is third degree polynomial.

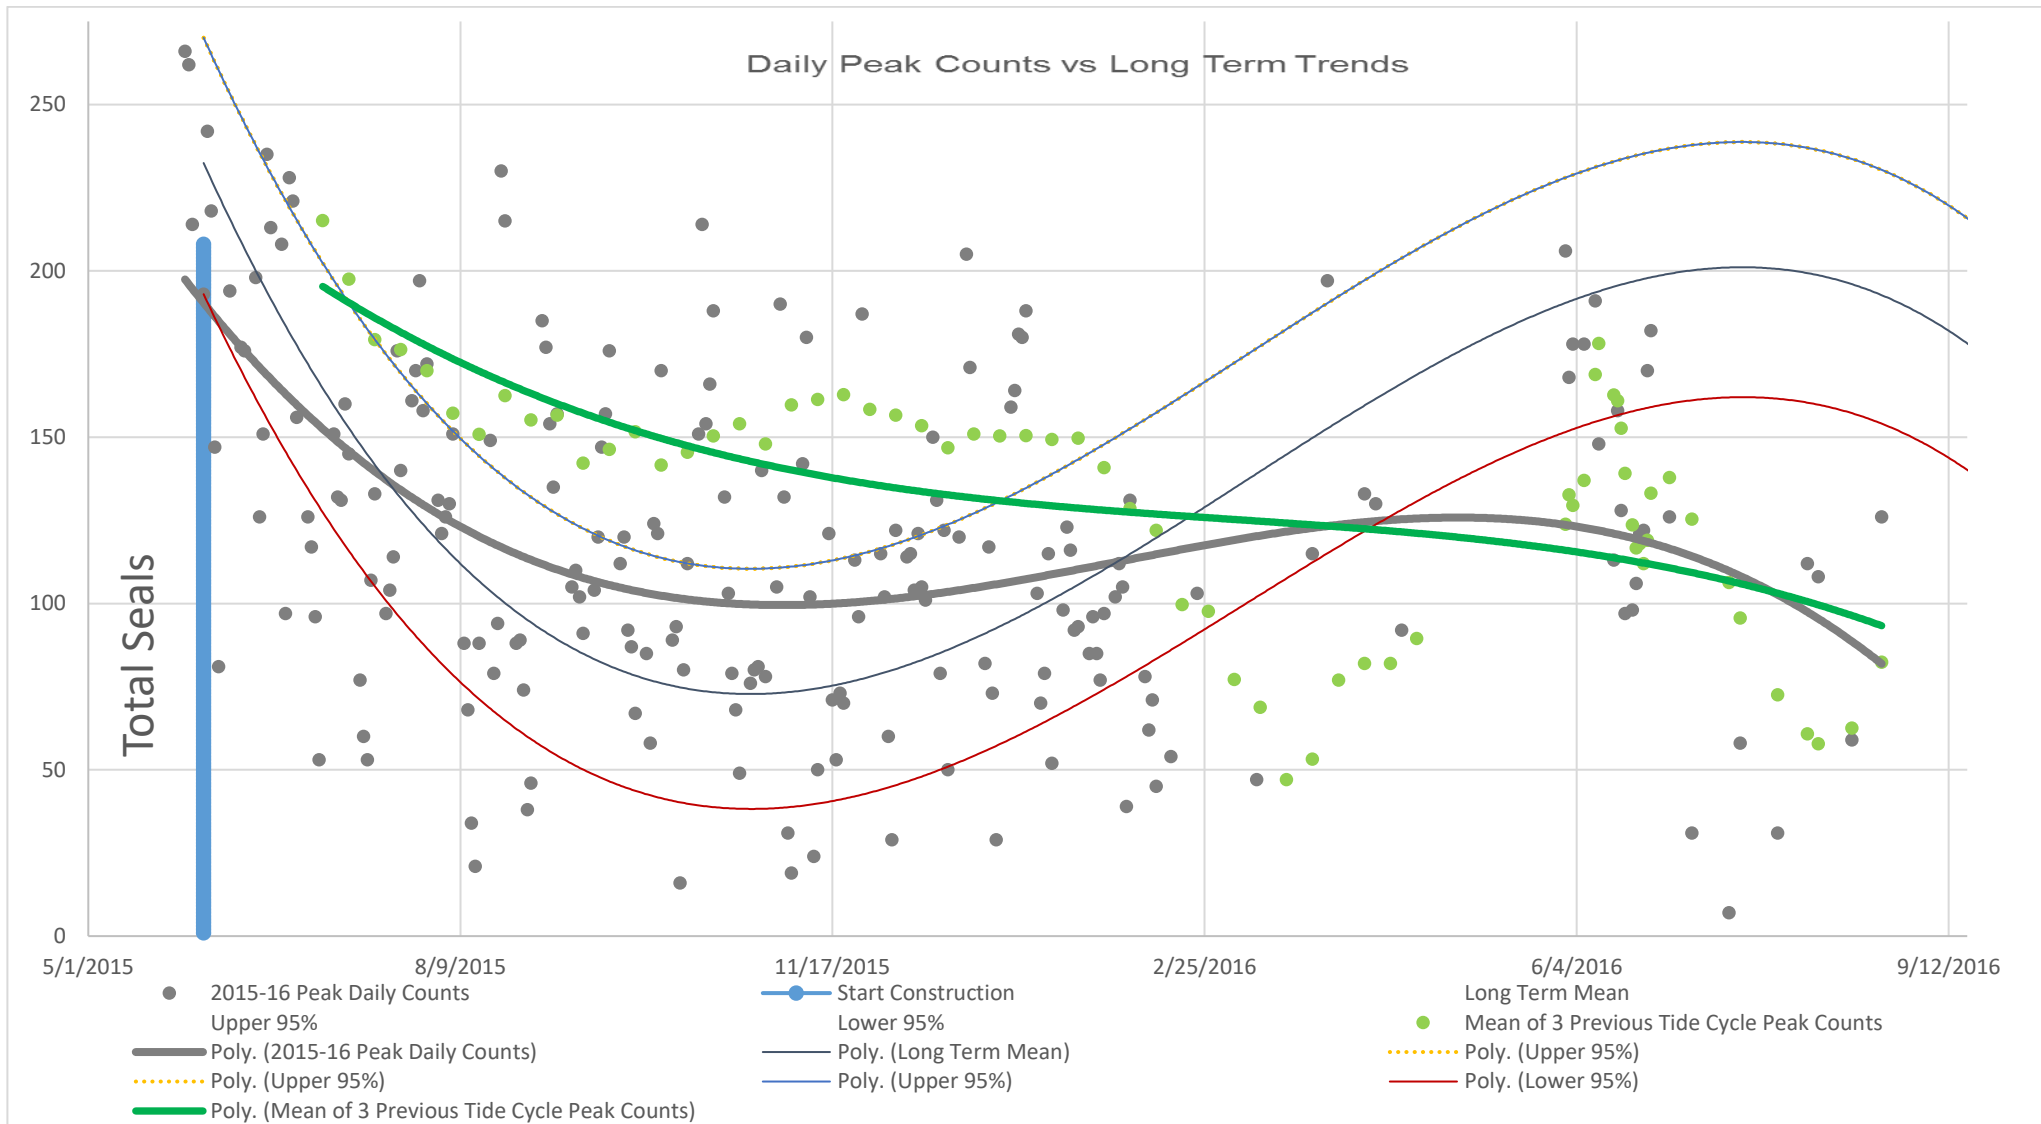
Counts and mean trends of seals observed during the periods authorized by the 2015 IHA are shown in Figure 8 fit with 3rd degree polynomial trend line; predicted harbor seals hauling out by day as projected from previous studies at CP with upper and lower 95% confidence intervals. We note that CP Total and Area Total showed declining trends prior to start of construction. We observed that public interactions seemed to be increasing during that time and also noted that there were large numbers of seals hauling out at night and into early morning hours (Figure 10). We moved our daily monitoring start time to just before dawn rather than just before construction, frequently an hour or more before start of construction. During this time period, our peak count for monitoring was often during the first or second count of the day, before people started arriving at CP. Because of human disturbance at CP, daily peak counts

Figure 8. Children's Pool Harbor Seal Peak Daily Counts (gray) with trend line and running mean of counts (green) during three tide cycles which stays above the lower 95% confidence level until March when observations dropped from daily to weekly; Predicted long term haul out curve with upper and lower 95% Confidence Levels and a solid vertical line (blue) for start (6/1/2016) of construction.

- After the first two months of monitoring in 2015, H&A evaluated mean and peak counts of harbor seals at CP relative to historic and projected abundance estimates (Figure 8) and presented the findings to NOAA Fisheries. Based on those data, we determined that harbor seal numbers were above the lower 95% confidence interval relative to the historic long term mean and therefore, site abandonment was not likely.

- regarding weekly mean comparisons to the previous three tide cycles please see Figure 8 which shows a running six week mean for CP. This mean is above the lower 95% for the predicted CP mean based on previous CP studies throughout the 2015-16 construction period until approximately April 9, 2016. At that date H&A was monitoring a random day once per week, construction was still occurring but also randomly. Concerned citizens reported to H&A and NOAA Fisheries when they observed construction activities, additionally H&A reported to NOAA Fisheries and the City of these activities. The City posted a stop work order on April 20, 2016 and we did not see or hear of any more construction until June 1, 2016, after the pupping season.

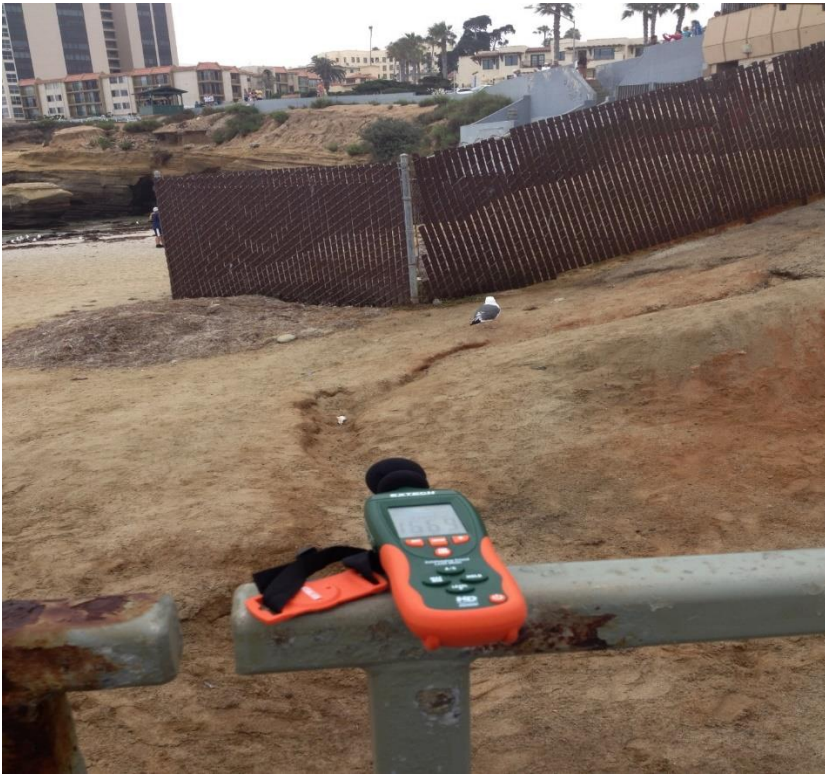
We recorded sound using an Extech® Instruments (model HD600) digital, handheld sound level meter recording in decibels. We recorded the maximum sound within a two-minute interval, fast (125 ms) response time, A-weighting, within a range of 30 - 130 dB as recommended by the manufacturer and distributor. The meter was calibrated periodically using a Reed SC-05 sound level calibrator. When seals were above or very near the rope at the center of CP beach, we often did not go onto the beach to take recordings in order to avoid possibly flushing the seals. However, if members of public had already approached the seals at the rope, we proceeded with the recordings at all stations. For safety, no measurements were taken at Break Wall 1 or 2 when waves were breaking over the seawall. During 2015-16, mean ambient sound **with no construction** for all seven monitoring stations was 68.7 dB re 20 µPa with a range of 52.3 to 90.5 dB re 20 µPa. Mean average sound **with construction** for all seven monitoring stations was 71.1 dB re 20 µPa with a range of 52.8 to 105.0 dB re 20 µPa. This maximum recording was taken next to the construction fencing at CPT (Top of Stairs) and was a recording of steel materials being unloaded (dropped) by a fork lift about 1 meter away from the recorder. There was no alert or flush of the 12 seals hauled out on the rocks below the sea wall (about 60 meters away, Figure 11). Please see Table 2 for summary results of recorded sound levels by individual type of equipment.

Figure 9. Monitoring location Break Wall 1 and sound meter on break wall railing.

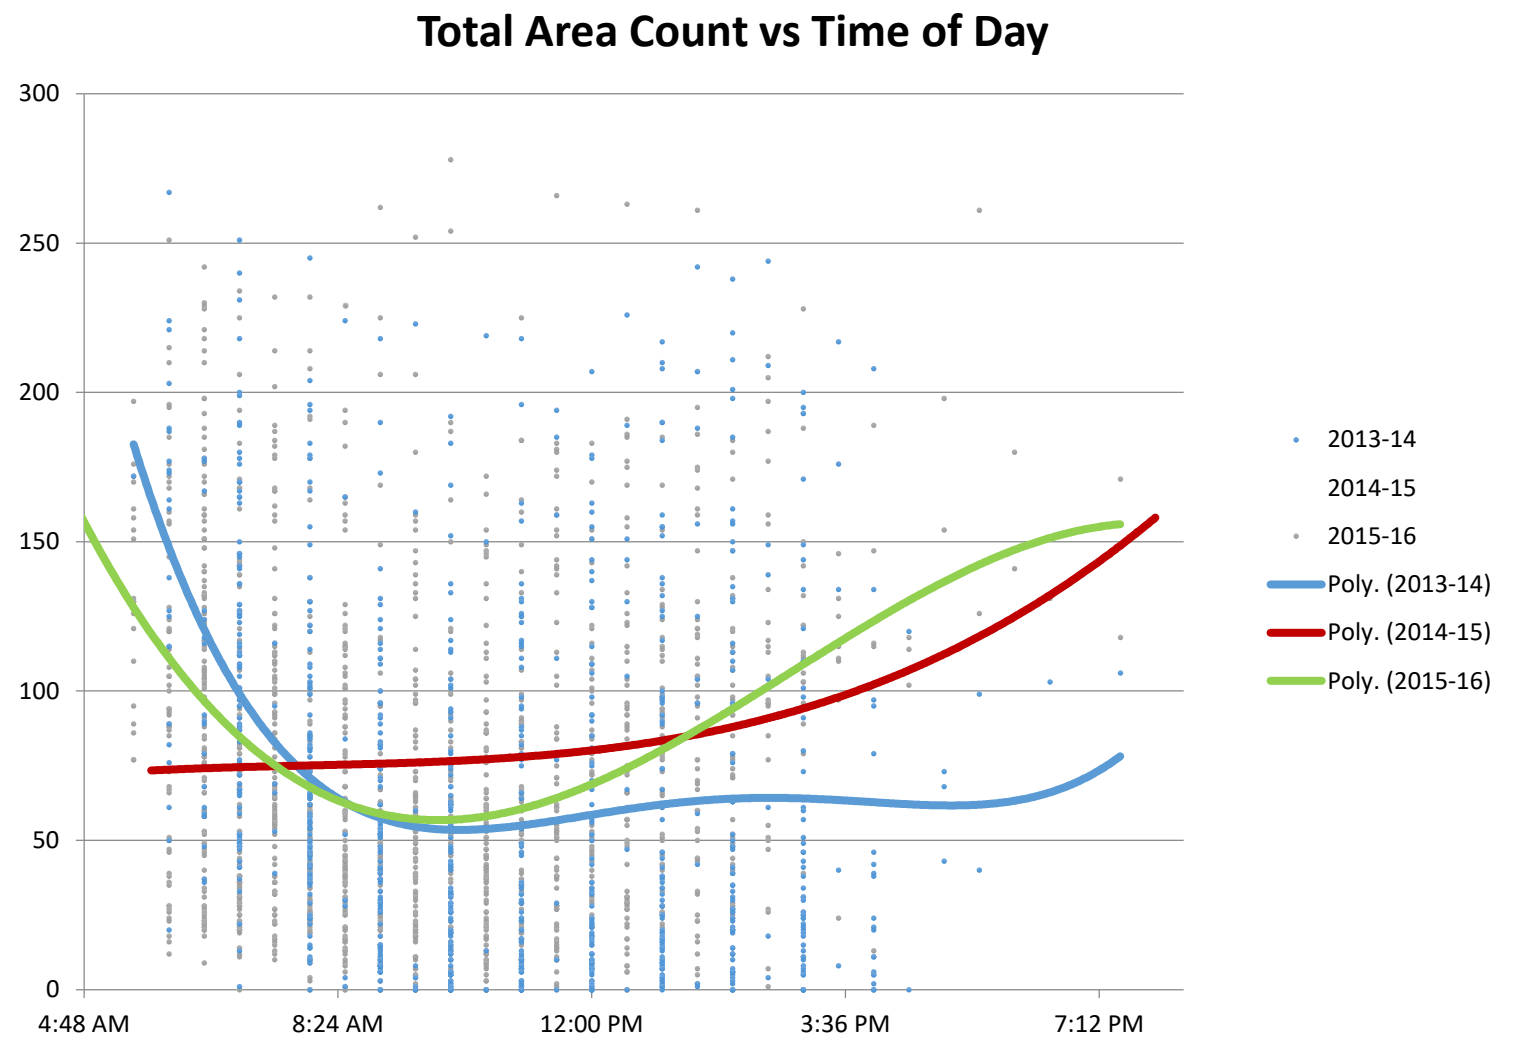
The trend lines in Figure 9 below shows a relationship which we noticed both before and during construction: that the number of seals tend to decline as the city starts to awaken and the day progresses; people start arriving at CP for various activities not always related to seal watching: joggers and walkers, traffic passing by, maintenance of facilities and landscaping, trash trucks, lifeguard activities, storm water sampling, seal photographers, and seal enthusiasts. The total number of seals then increases in the afternoon.

Figure 10. Comparison of 2013-14, 2014-15, and 2015-16 harbor seal counts by time of day. Note early morning declining trend followed by afternoon increasing trend.

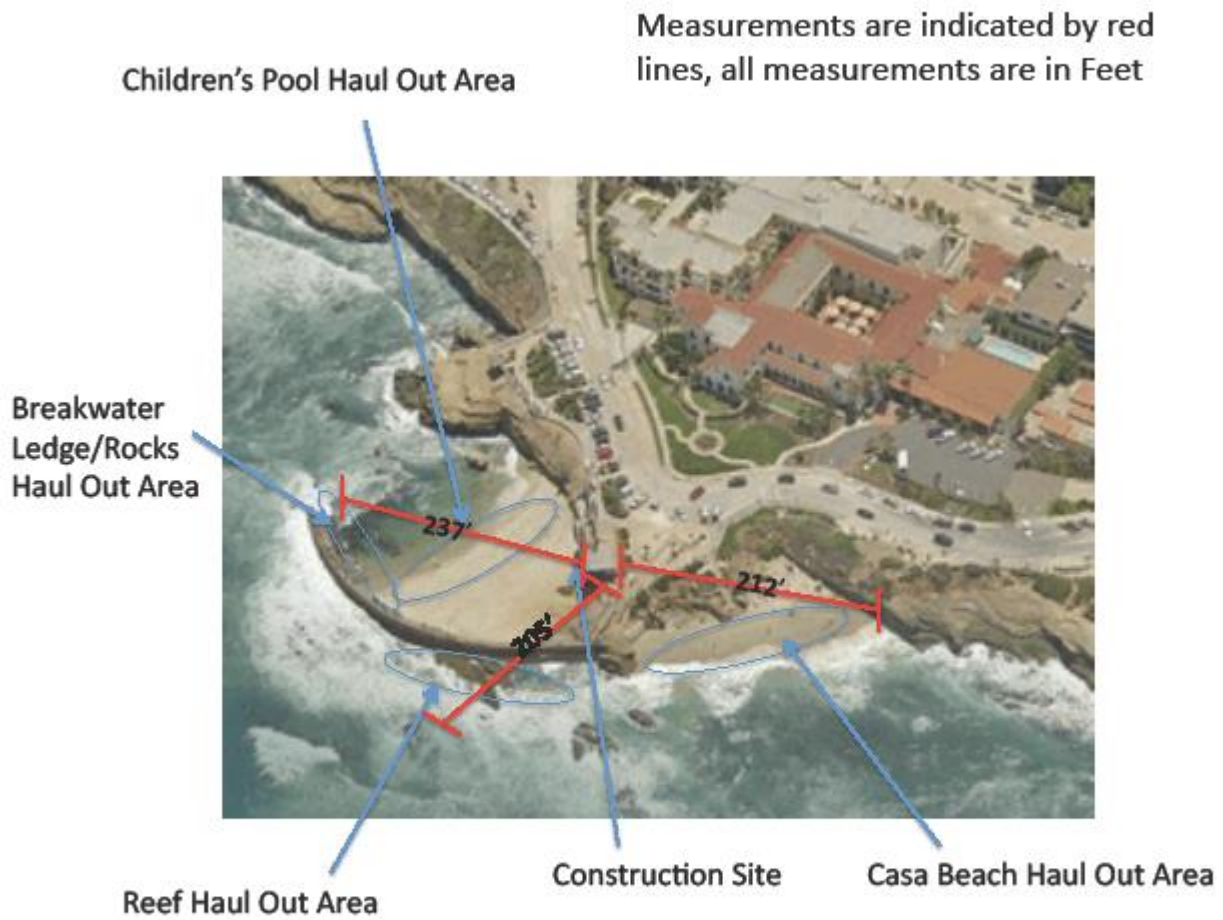
Top of Stairs (CPT) and Casa (Figures 10 and 11) are two locations closest to construction just outside safety fencing. Middle Rope (CPM) location is about midway across Children's Pool beach and next to the City installed rope barrier. CPB is at the south end of CP beach at the bottom of the access stairs.

Figure 11. Children's Pool construction site and measurements away from construction site.

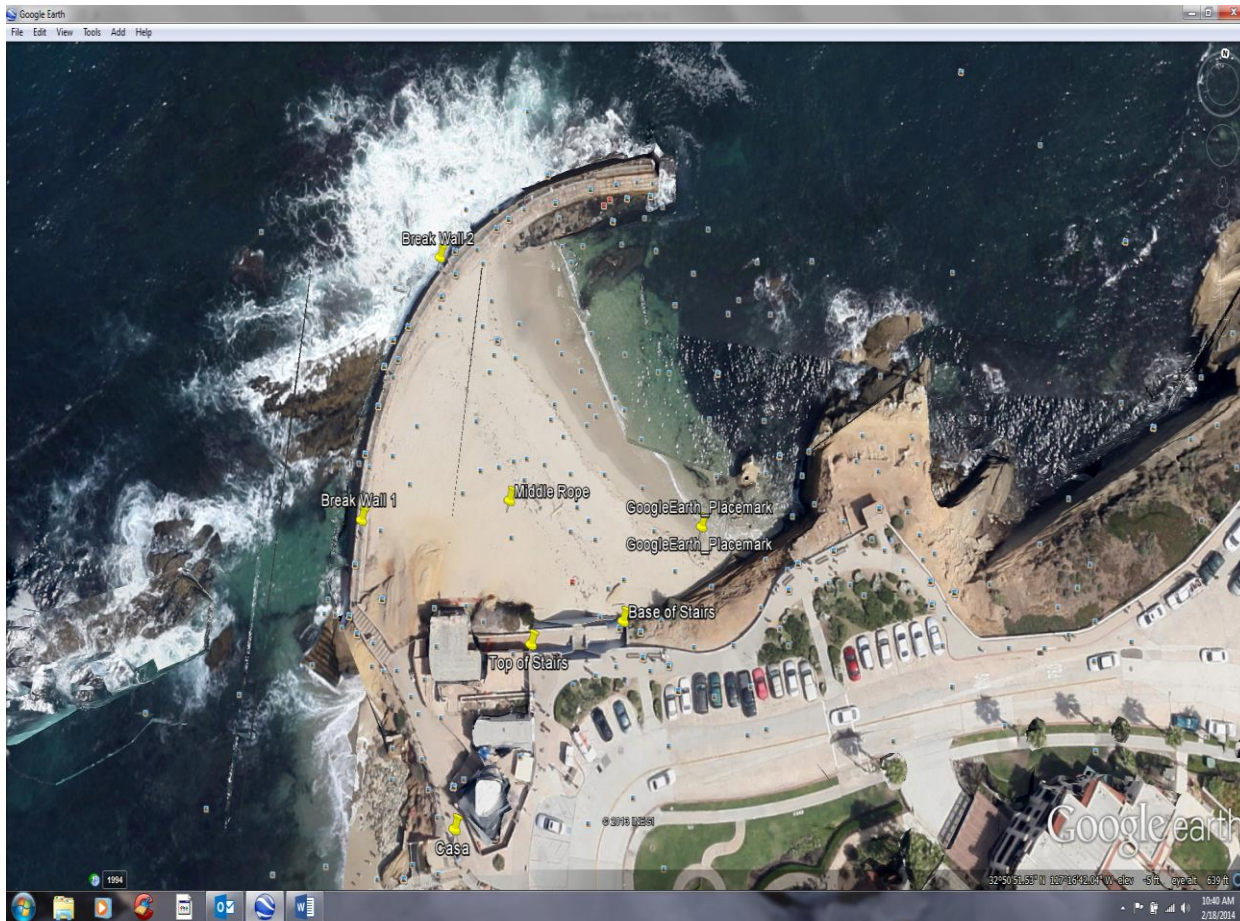
Figure 12. Location of monitoring stations (Top of Stairs, Bottom of Stairs, Middle Rope, Casa, Break Wall 1, and Break Wall 2) at Children's Pool, La Jolla, CA.

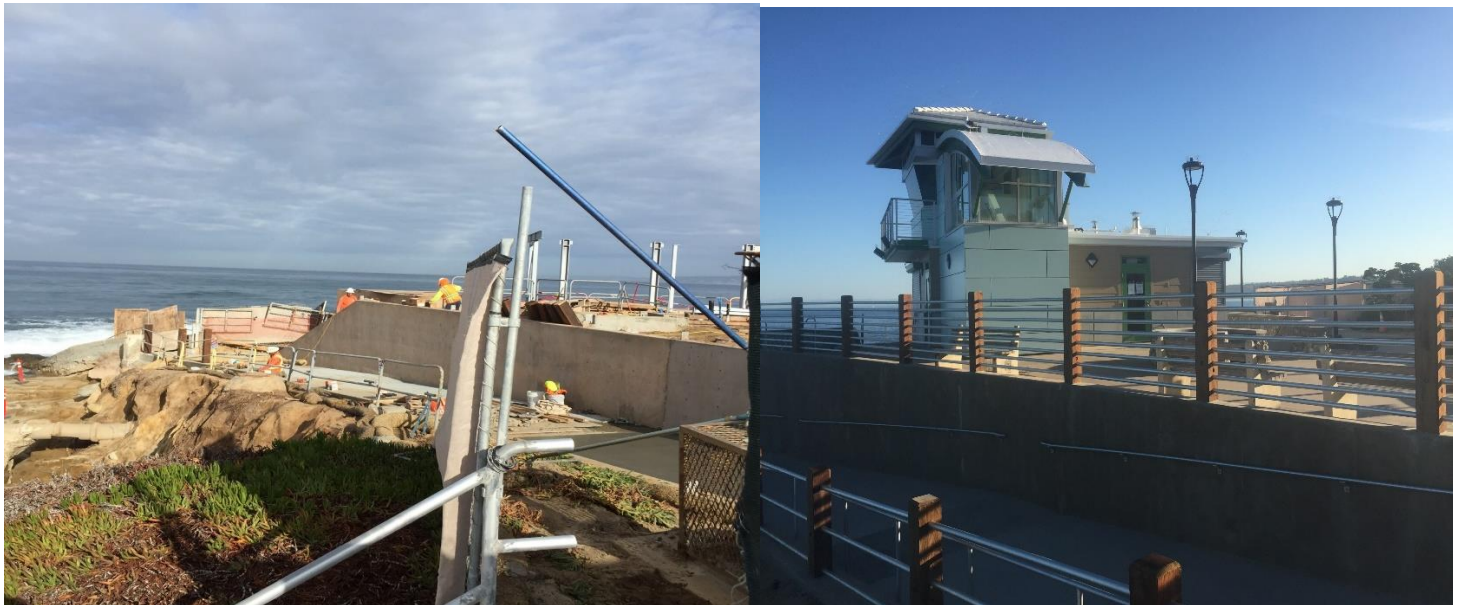
Figure 13. Monitoring location: Casa early and late 2015 (above Casa Beach and next to construction site).

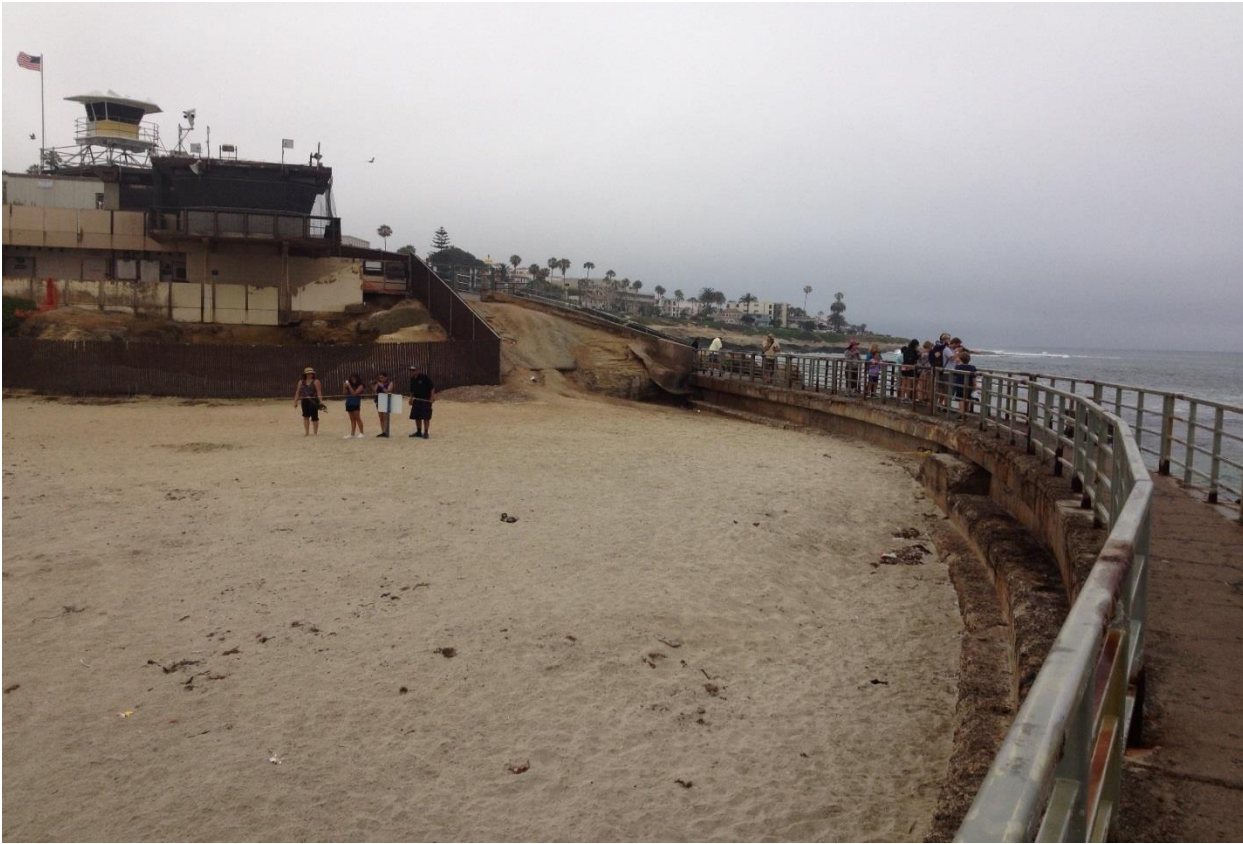
Figure 14. View from monitoring location: Break Wall 2. Note Break Wall 1 located this side of second man on wall (tan shirt) and note yellow rope barrier on beach at white sign with four people standing on beach.

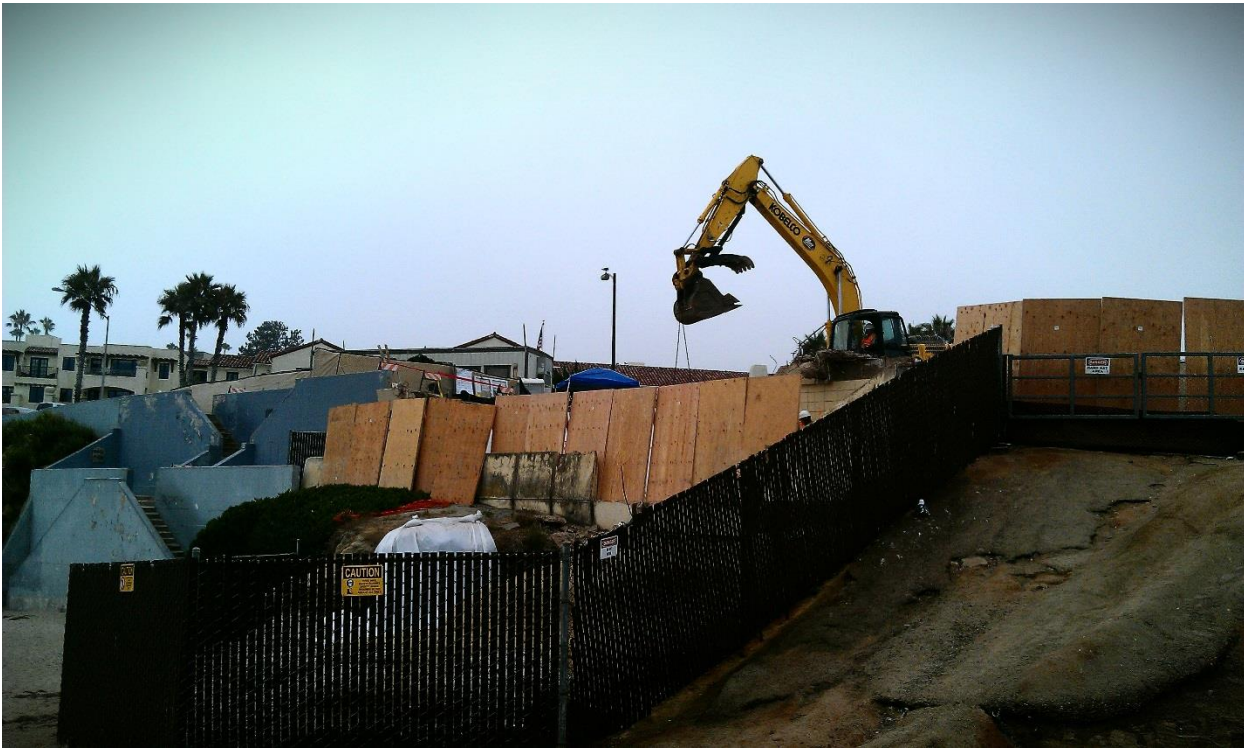
Figure 15. Moving visual/acoustic barriers to lower level of construction site after removal of old building.
